*TECHNICAL REPORT ON OPERATION TIMES  
FOR DUCT MOUNTED, CORROSION  
PROTECTED SPRINKLERS AND THE  
INFLUENCE OF SPRINKLER SPRAY ON HEATED  
AIR FLOW THROUGH DUCTING*

*Prepared by  
Underwriters Laboratories, Inc.  
Project 97NK29176, NC1838  
for  
HSB Industrial Risk Insurers  
June 5, 1998*

SPECIAL SERVICES INVESTIGATION OF  
Operation Times for Duct Mounted, Corrosion Protected Sprinklers and the Influence of  
Sprinkler Spray on Heated Air Flow Through Ducting

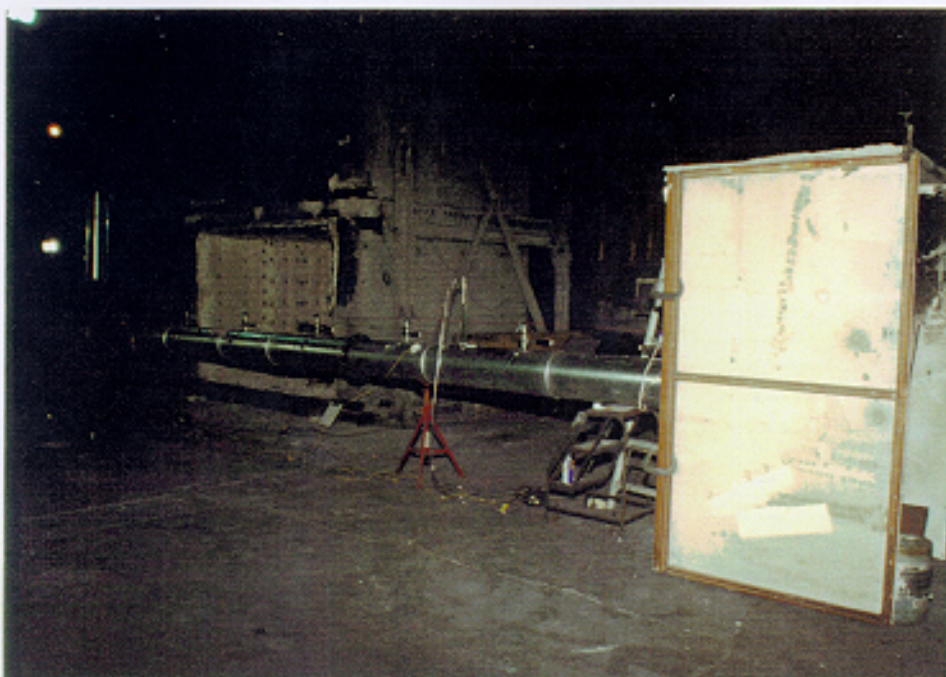
**Figure 1 – Task 2 and 3:**  
Test set-up showing  
Enclosure to the  
Right and duct.

**TASK 2:** A nominal 1 foot diameter galvanized steel duct with a 18 gauge wall thickness was utilized for the Task 2 and 3 tests. The duct was approximately 25 feet long and incorporated 6 positions for sprinklers as shown in Fig. 1 and Figs. 1 and 2, Appendix A. The sprinklers were positioned inside the duct through the use of removable plates which conformed to the curvature of the duct (see Fig. 1 and Fig. 3 and 14, Appendix A). These plates were manufactured from galvanized steel and had a thickness of 0.060 inch. A bulkhead fitting was used to attach the sprinkler to the curved plate. The plate was then positioned over a 2" diameter hole in the duct which accepted the sprinkler/curved plate. The pendent style sprinkler was installed perpendicular to the longitudinal axis of the duct. The positioning of the sprinkler had the deflector approximately 2-1/2 inches inside the duct (see Fig. 5, Appendix A).

A 12 inch by 12 inch by 8 inch deep pan, filled with a quantity of heptane was used to develop the heat necessary to activate the sprinklers (see Figs. 7 and 8 Appendix A). A 4 foot by 4 foot by 7 foot high, 5 sided enclosure was constructed around the pan to control the geometry of the resulting fire (see Figs. 1 and 4, Appendix A).

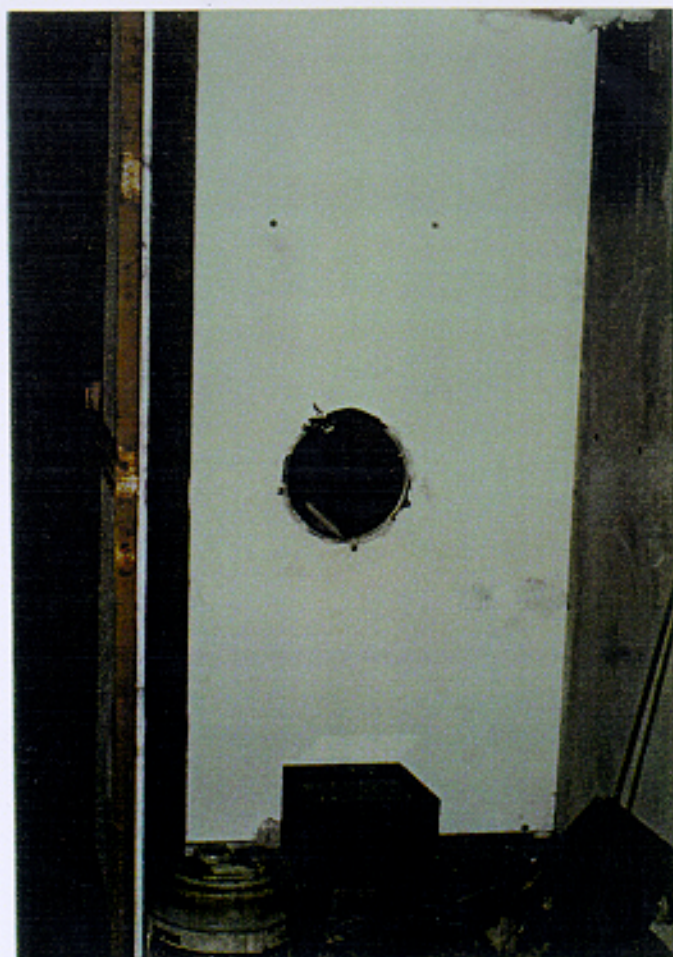
**Figure 4 – Task 2:**  
Test set-up showing  
Heptane pan location  
With respect to duct  
inlet.

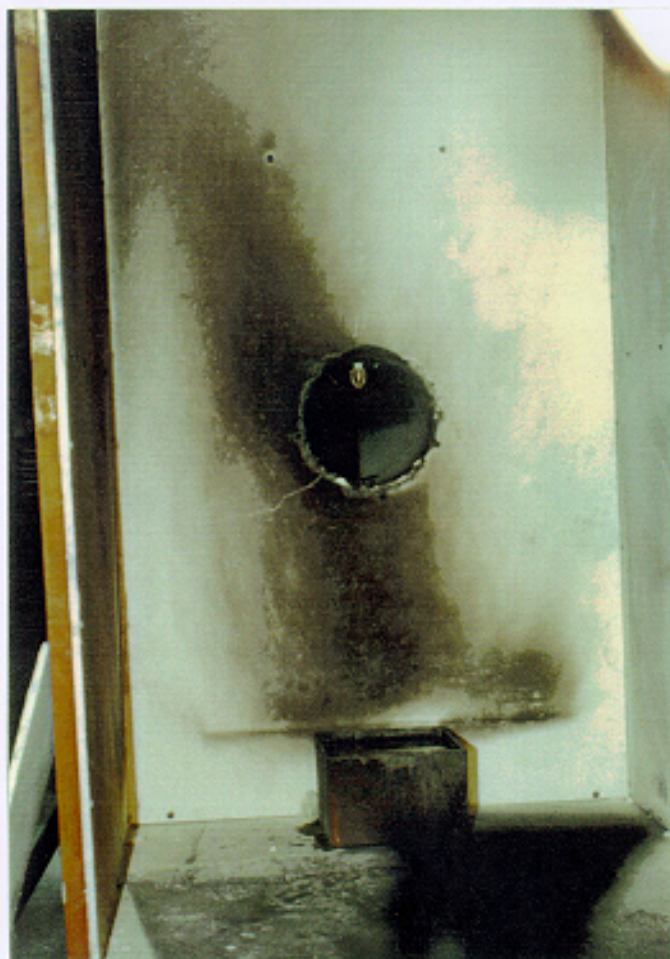
**Figure 6 – Task 2:**

Test #2 pre-test.  
scorch marks on  
drywall from test #1  
can be seen.

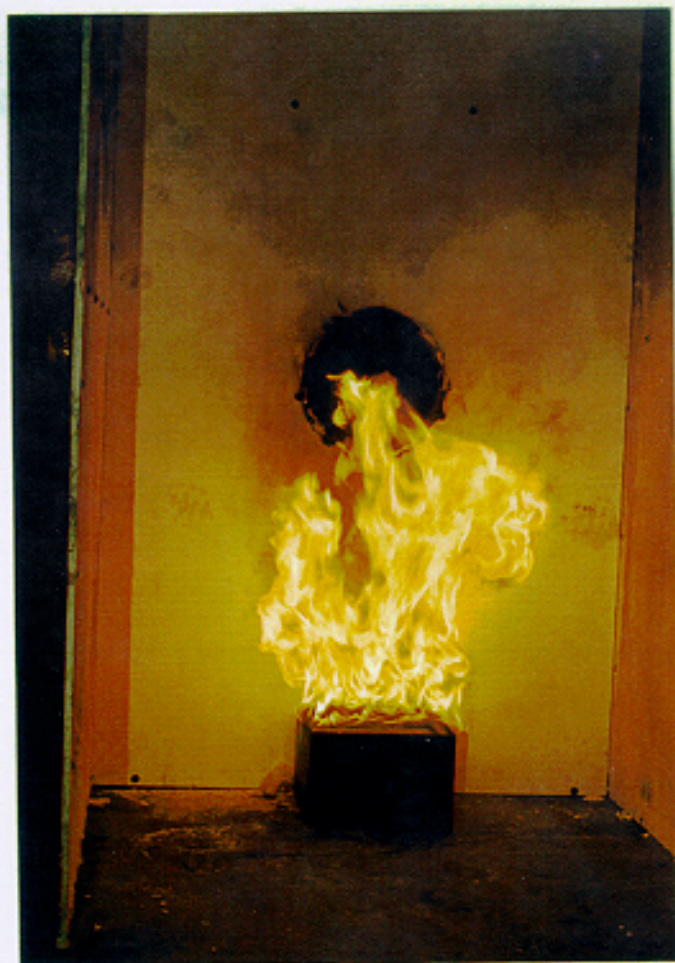
Figure 8 – Task 2:  
Test #1 fire developed.

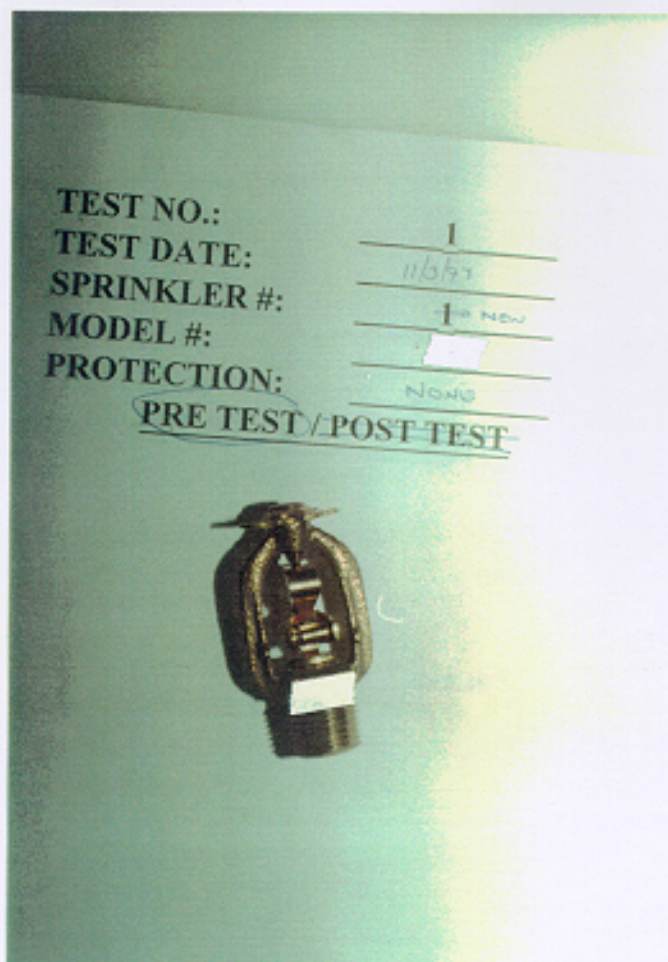
**Figure 9 – Task 2:**  
Test #1 sprinkler prior  
to test.

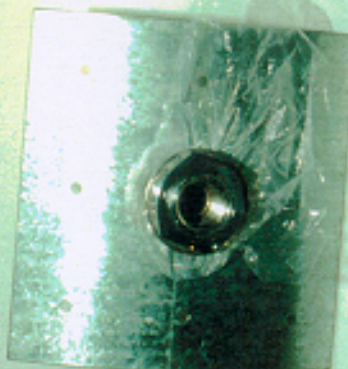
TEST NO.: 3  
TEST DATE: 11/4/97  
SPRINKLER #: [redacted]  
MODEL #: [redacted]  
PROTECTION: SINGLE LIGHT TIGHT BAG  
PRE TEST / POST-TEST

**Figure 14 – Task 2:**  
Test #3 – Representative  
sprinkler assembly for  
positions 2, 4 and 6 (light  
bag through bulkhead  
from top of assembly).

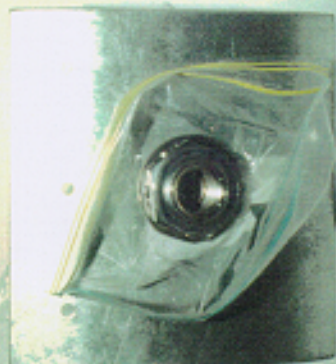
TEST NO.: 3  
 TEST DATE: 11/4/97  
 SPRINKLER #: 3 NEW  
 MODEL #:   
 PROTECTION: SINGLE HEAVY WTS BAG  
PRE TEST / POST-TEST

**Figure 15 – Task 2:**  
 Test #3 – Representative  
 sprinkler assembly for  
 position 1, 3 and 5  
 (heavy bag through  
 bulkhead fitting  
 from top of assembly).

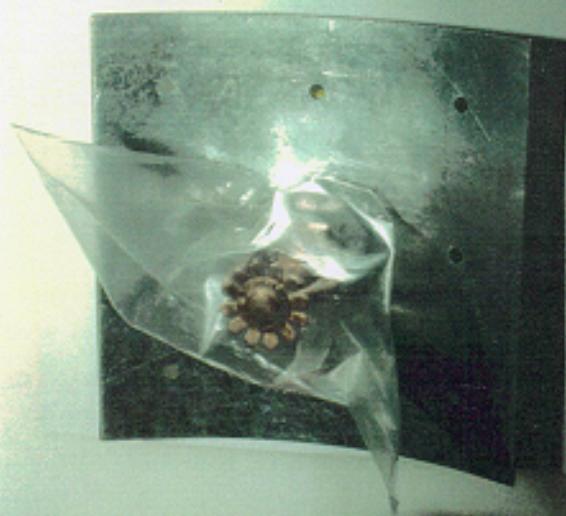
TEST NO.: 3  
 TEST DATE: 11/4/97  
 SPRINKLER #: 3 NEW  
 MODEL #:   
 PROTECTION: SINGLE HEAVY WTS BAG  
PRE TEST / POST-TEST

**Figure 16 – Task 2:**  
 Test #3 – Representative  
 sprinkler assembly for  
 positions 1, 3 and 5  
 (heavy bag loosely  
 fitted around uncoated  
 sprinkler).

The plastic bagged sprinklers incorporated generic lunch style plastic bags with nylon ties near the sprinkler's wrench flat. The bag was installed loose fitting to the sprinkler (see Figs. 16 and 17, Appendix A). The commercially available flexible hose / adjustable drop nipple product incorporated it's own double plastic bag with gasket assembly which attaches between a set of metal mounting blocks (see Figs. 34, 52 and 54,

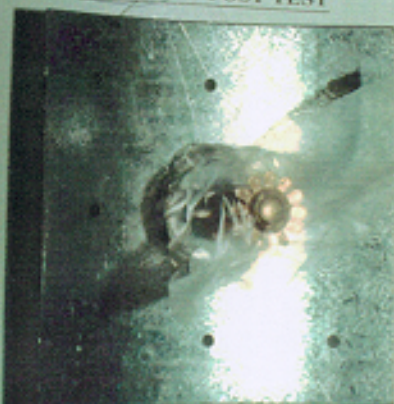
TEST NO.: 3  
TEST DATE: 11/4/97  
SPRINKLER #: 2  
MODEL #:   
PROTECTION: SINGLE LIGHT WEIGHT BAG  
PRE TEST / POST-TEST

**Figure 17 – Task 2:**  
Test #3 – Representative  
sprinkler assembly  
for positions 2, 4 and 6  
(light bag loosely fitted  
around uncoated  
sprinkler).

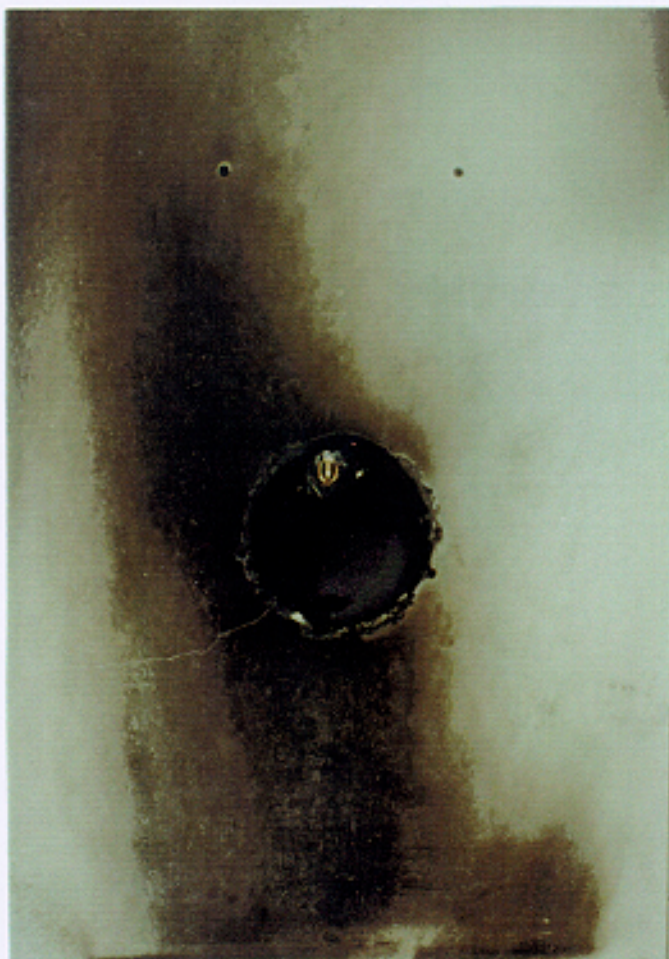
**Figure 18 – Task 2:**  
Test #3. Pretest showing  
sprinkler at position #1  
with heavy plastic bag.

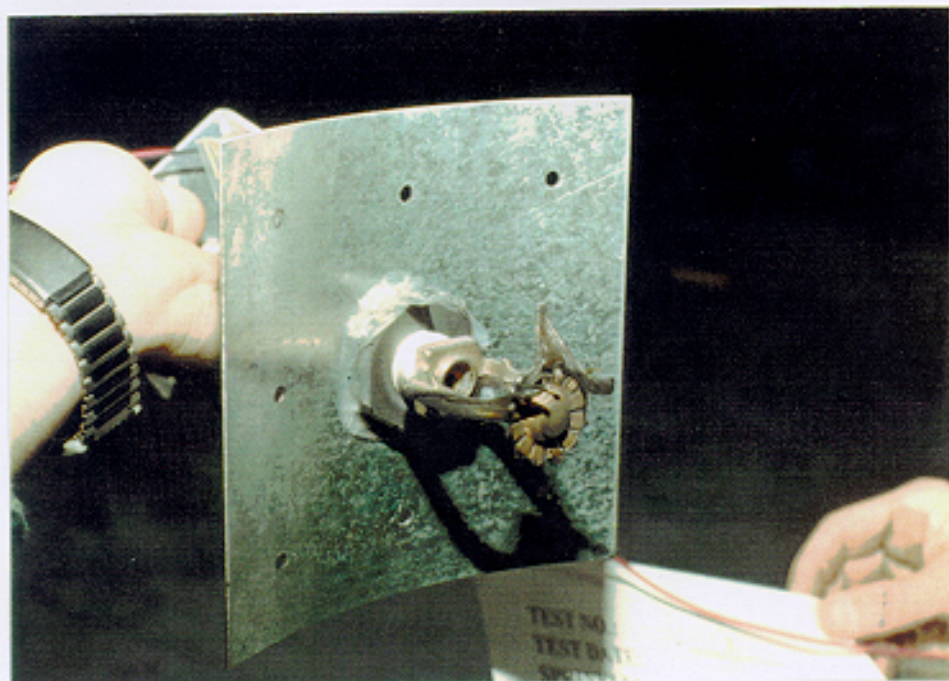
**Figure 19 – Task 2:**

Test #3, Post test of sprinkler at position #3 (heavy bag). The link and lever were retained by the plastic.

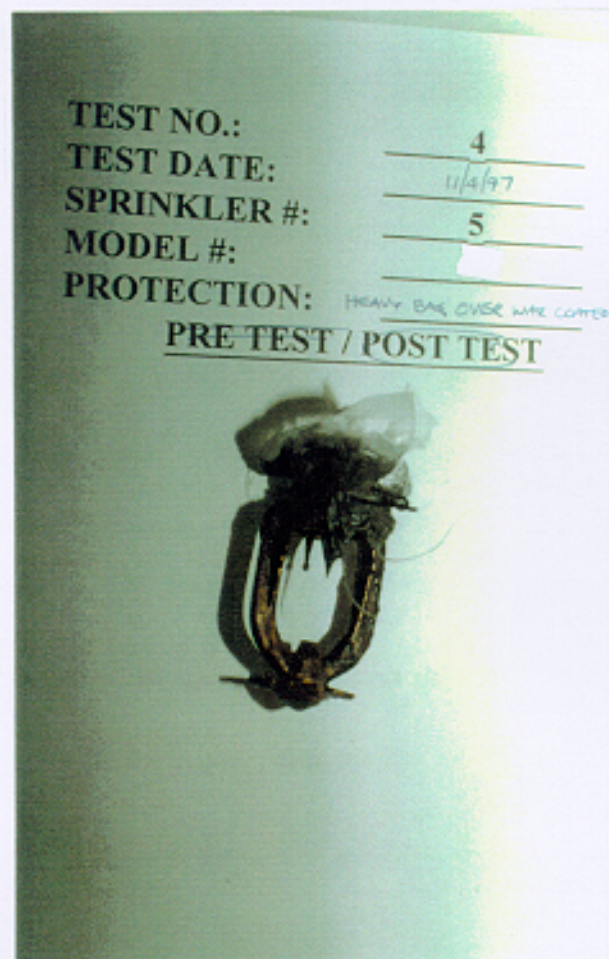
**Figure 28 – Task 2:**

Test #4, Post test of  
sprinkler at position #5,  
(heavy bag). No parts  
were retained.

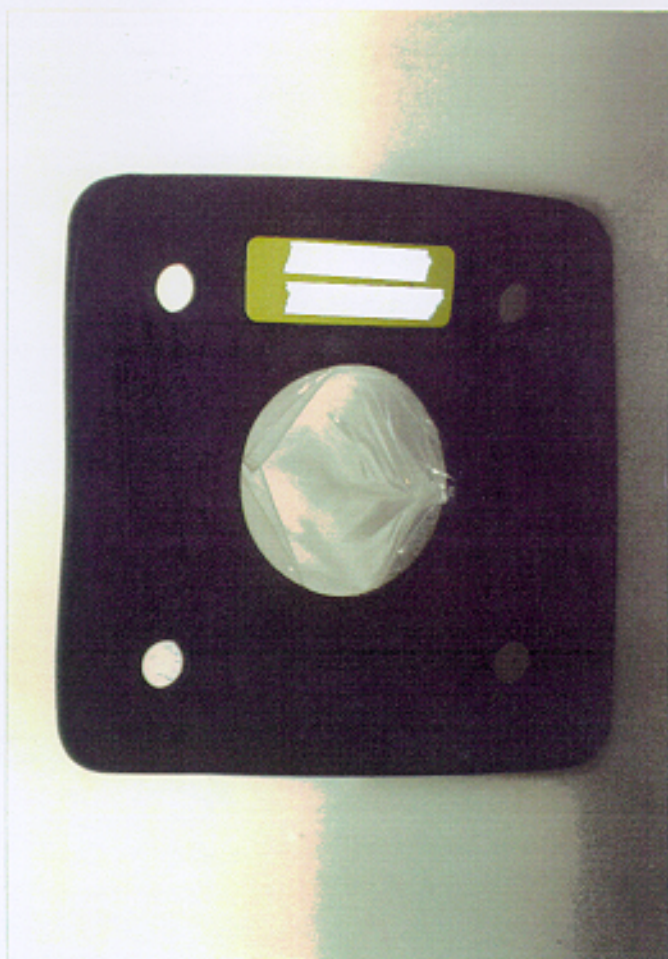
**Figure 35 – Task 2:**  
Test #6 / #10, Pre - test  
showing double plastic  
bag / gasket assembly  
(folded).

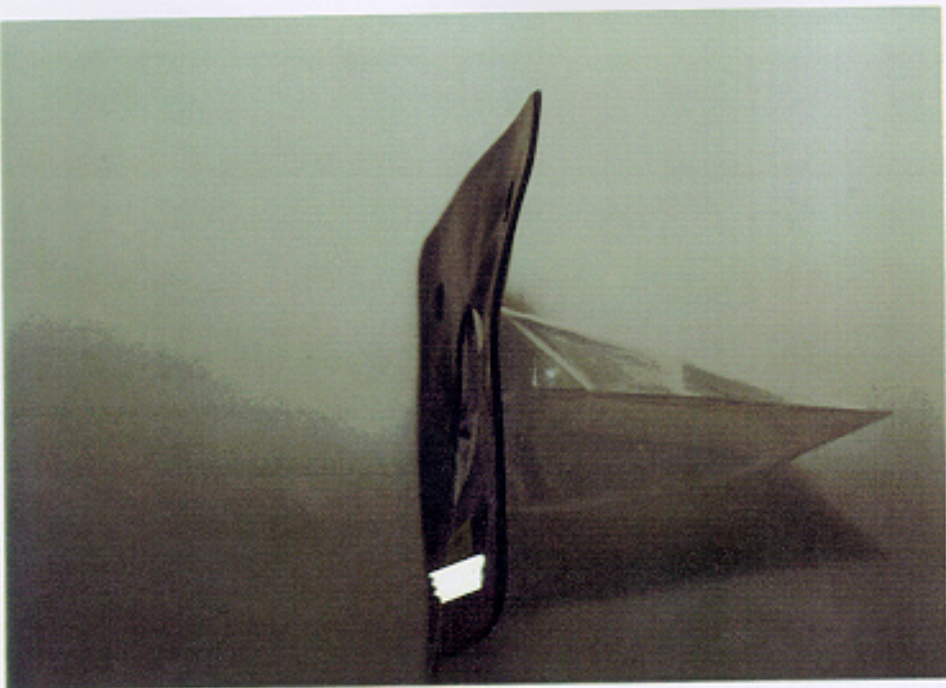
**Figure 37 – Task 2:**  
Test #6 / #10, Pre – test  
showing double bag /  
gasket assembly from  
side with bags unfolded.

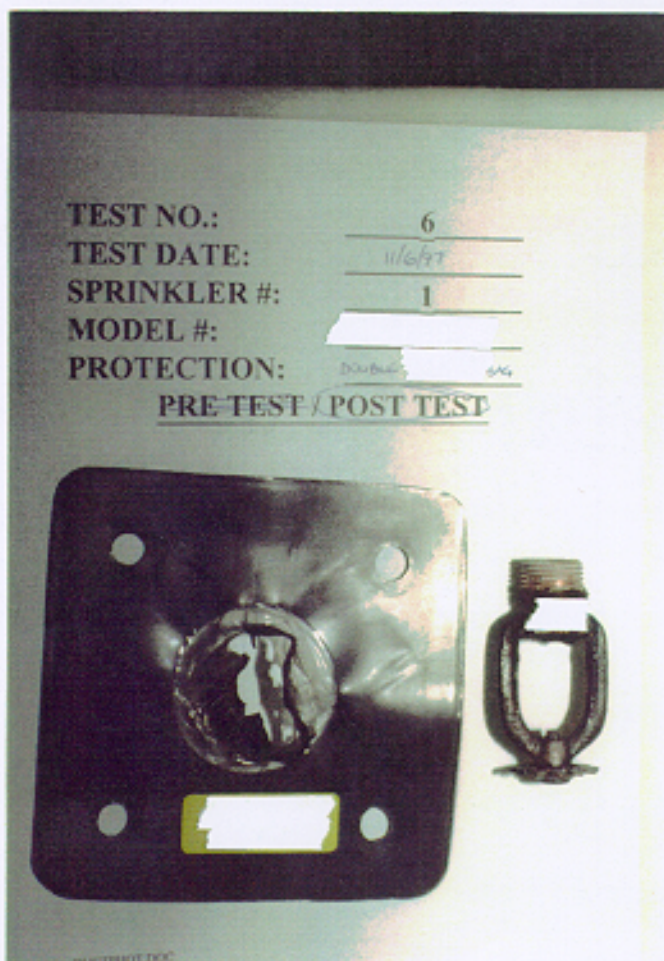
**Figure 38 – Task 2:**  
Test #6, Post test of  
sprinkler at position #1,  
with most of the plastic  
removed by heat. The  
gasket and the sprinkler  
were separated.

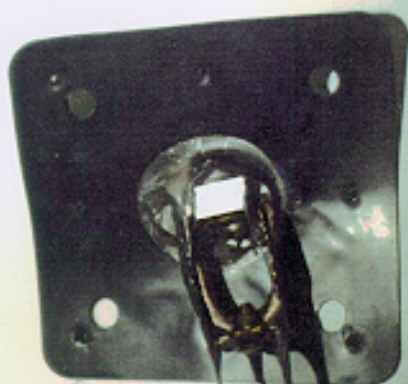
**Figure 39 – Task 2:**

TEST NO.: 6  
 TEST DATE: 11/6/97  
 SPRINKLER #: 5  
 MODEL #:   
 PROTECTION: Domestic 240  
PRE TEST / POST TEST

Test #6, post test of sprinkler at position #5. Gasket assembly retained sprinkler and the plastic retained the link and lever.

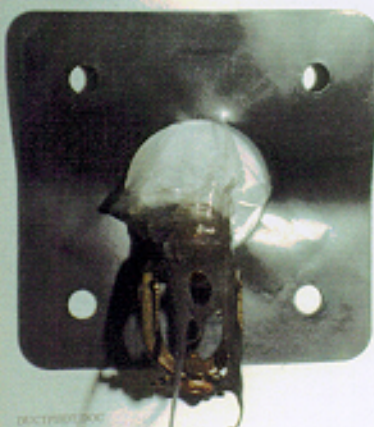
Test #6, Post test of sprinkler at position #6. Gasket assembly retained sprinkler, however no parts were retained.

TEST NO.: 6  
 TEST DATE: 11/6/97  
 SPRINKLER #: 6  
 MODEL #:   
 PROTECTION: Domestic 240  
PRE TEST / POST TEST

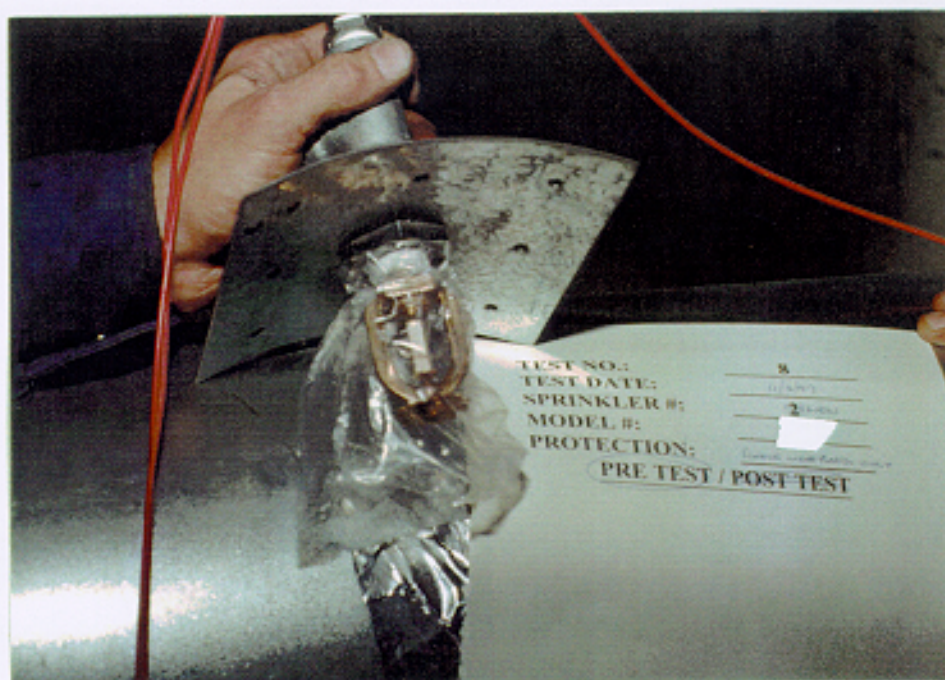
**Figure 42 – Task 2:**

Test #8, Pre - test  
showing single light  
bag over uncoated  
quick response  
sprinkler.

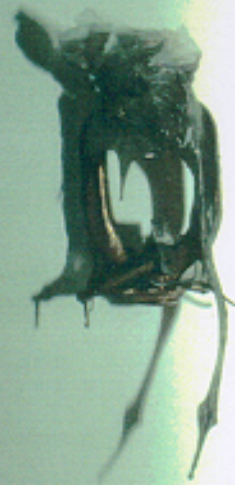
**Figure 46 – Task 2:**  
Test #8, Post - test  
of sprinkler at position  
#5 showing the kick out  
spring, link and lever  
being retained by a  
heavy plastic coating.

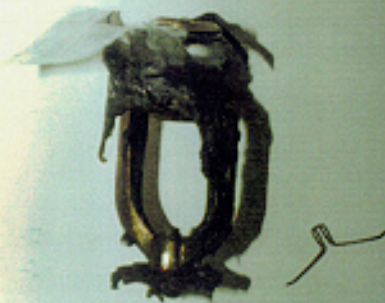
**Figure 49 – Task 2:**

Test #9, Post test of sprinkler at position #2 showing the kick out spring being partially retained with a light coating of plastic.

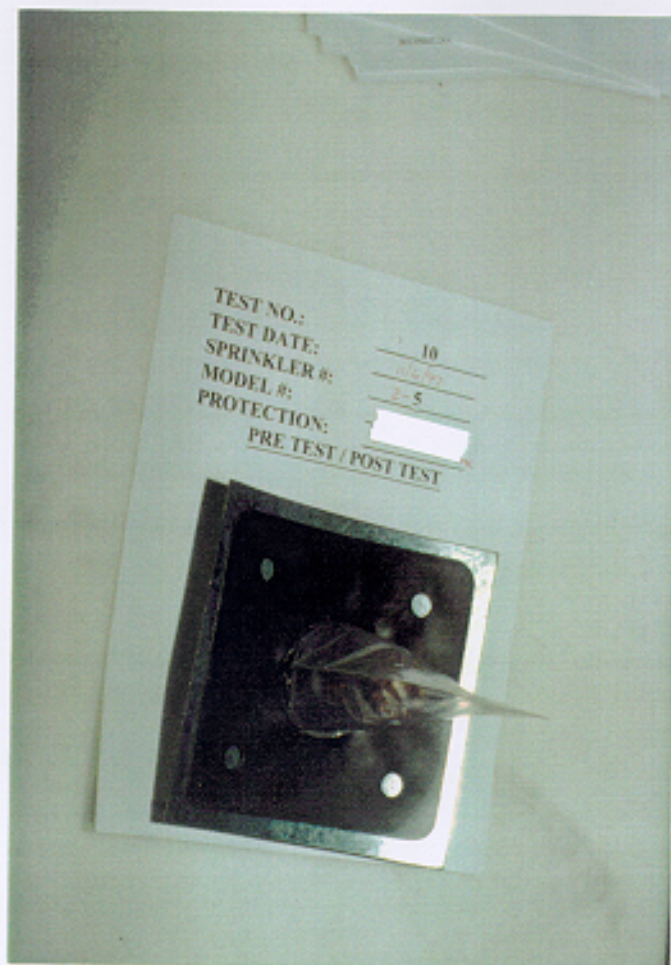
Test #10, Pre - test showing commercially available double bag / gasket assembly over an uncoated sprinkler attached to the flexible hose assembly (positions 1 and 6 had this assembly).

Test #10, Pre - test showing double bag / gasket assembly on the inside of the duct fitting, (positions 2-5).

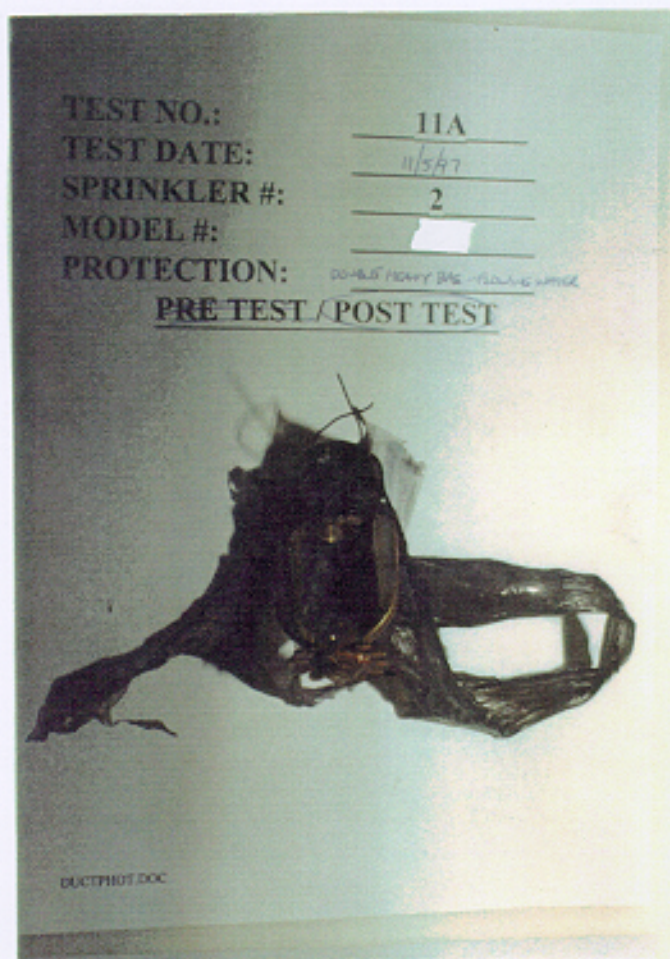
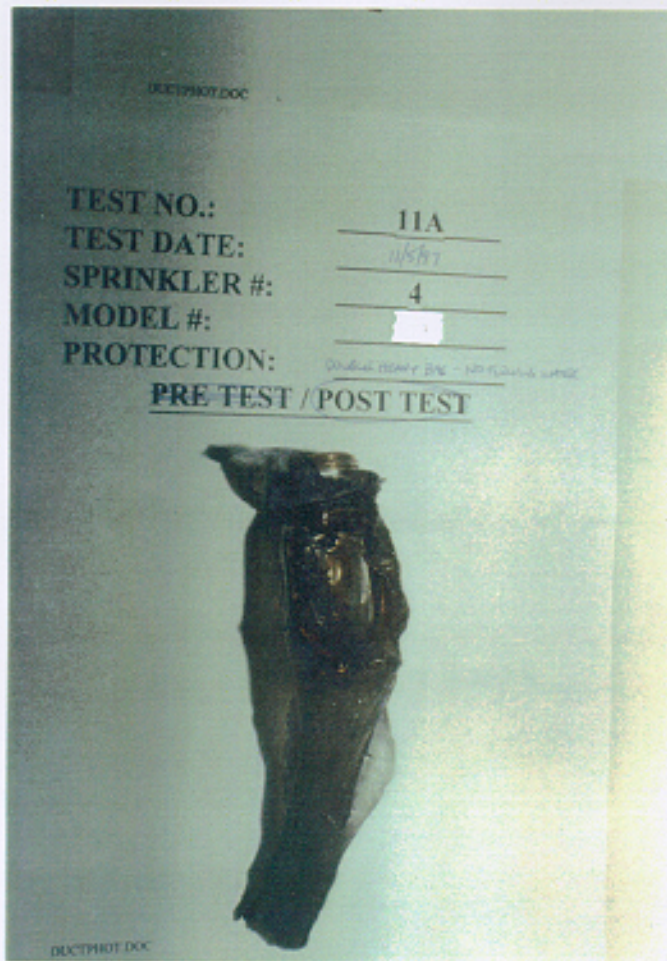
Test #11, Post - test of sprinkler at position #2 (sprinkler flowing water). No parts were retained and the deflector and the frame arms were cleared of the plastic. The plastic was hardened.

**Figure 59 – Task 3:**  
Test #11, Post test of  
sprinkler at position #4  
(non-flowing sprinkler),  
showing the plastic  
encasing the entire  
sprinkler. The sprinkler  
never operated. The  
plastic was hardened.

For the sprinkler at position 2, the double heavy plastic bag was distorted and did not adhere to the sprinkler's deflector or most of the frame arms, such that the discharge pattern potentially was not effected by the corrosion protection method employed. For the sprinkler at position 4, the double plastic bag totally encased the sprinkler and hardened due to the sprinkler discharge.
